**Decay Testing of a Singe Oak Tree, Alderbury,
On Behalf of Alderbury Parish Council.**

10th December 2024

**ARBORICULTURAL
CONSULTANTS**

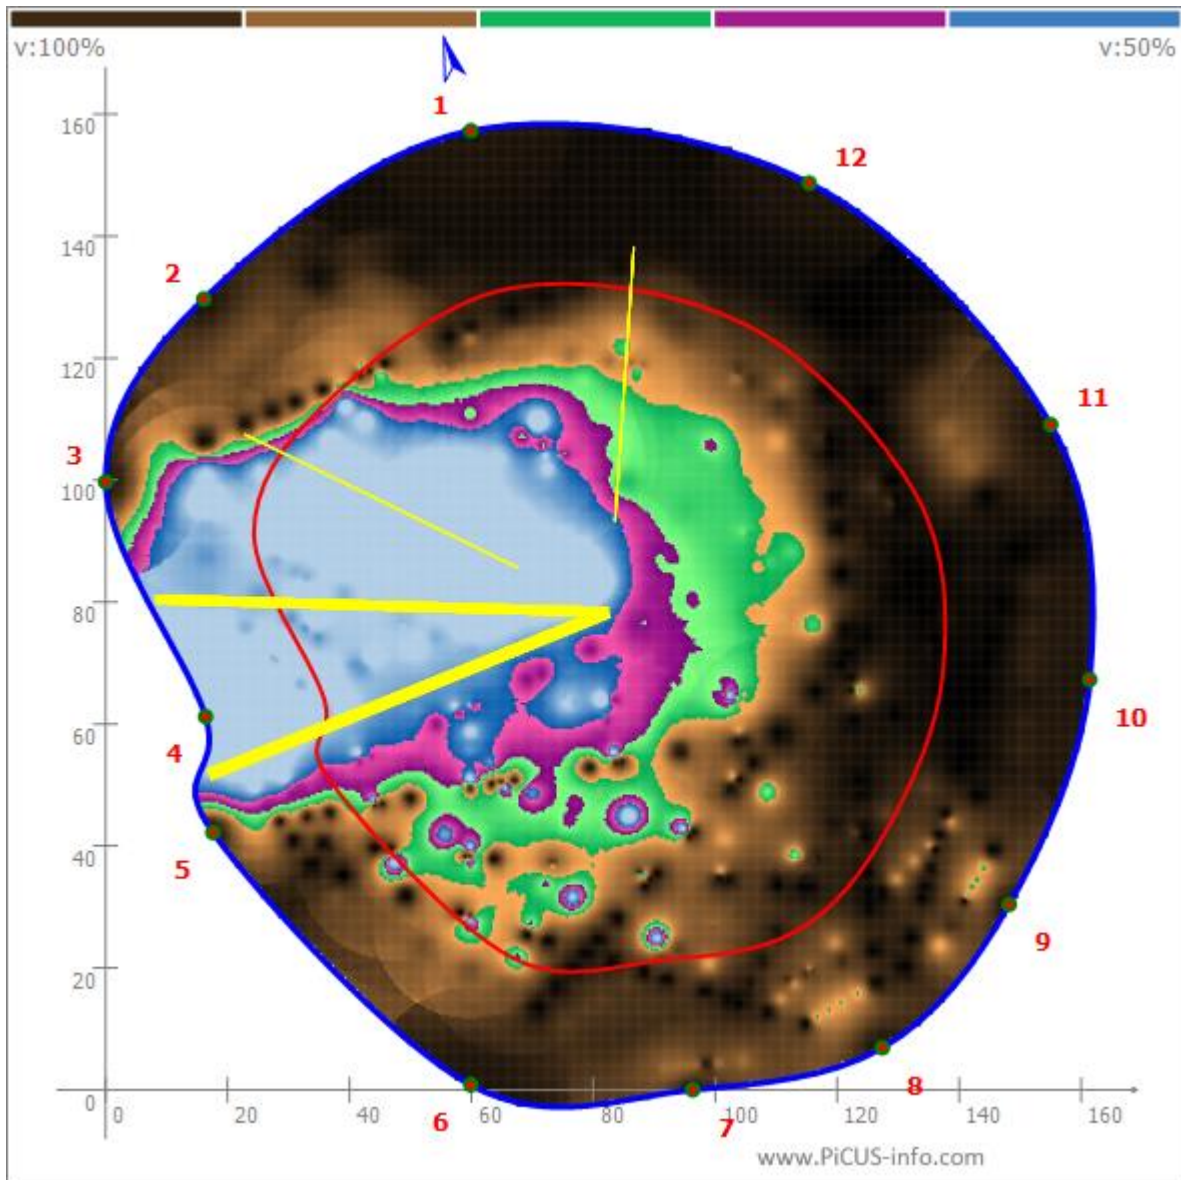
- 8.5 Sonic tomography results showed decay at the level of testing (circa 20cm above ground level) on the western side of the stem. The decay is largely localised and most extensive at the western part of the base, reducing as it extends towards and beyond the centre of the tree. Further testing was undertaken by an IML-RESI PD400 Microdrill at measuring points 2, 6, 10 and 12, to measure the thickness and strength of residual wood, and to verify the tomograph results.

- 9.1 The results of the sonic tomography verified the microdrill, indicate that the tree has localised basal decay which is not yet considered to be advanced. There is sufficient sound residual wood for the tree to be retained.

Results of PiCUS tomography at circa 30cm above ground level.

- 9.2 As the decay advances in the future, it is likely that the tree will be required to be reduced in height and spread to enable safe retention. For the tree to be able to cope with the loss of photosynthetic material in this operation, and to compartmentalise pruning wounds, its vitality must be improved. If cars continue to park beneath the tree causing further compaction, vitality will not improve. It is therefore recommended that a low-level post and rail fence is constructed or large rocks placed at the grass edge to prevent parking. The protected area should then be mulched to a depth of 100mm with partially rotted woodchip (not in contact with tree trunk). This should be completed at the earliest opportunity.

- 9.4 The tree should be inspected and tested for advance of decay every two years by a suitably qualified and experienced arboriculturalist.

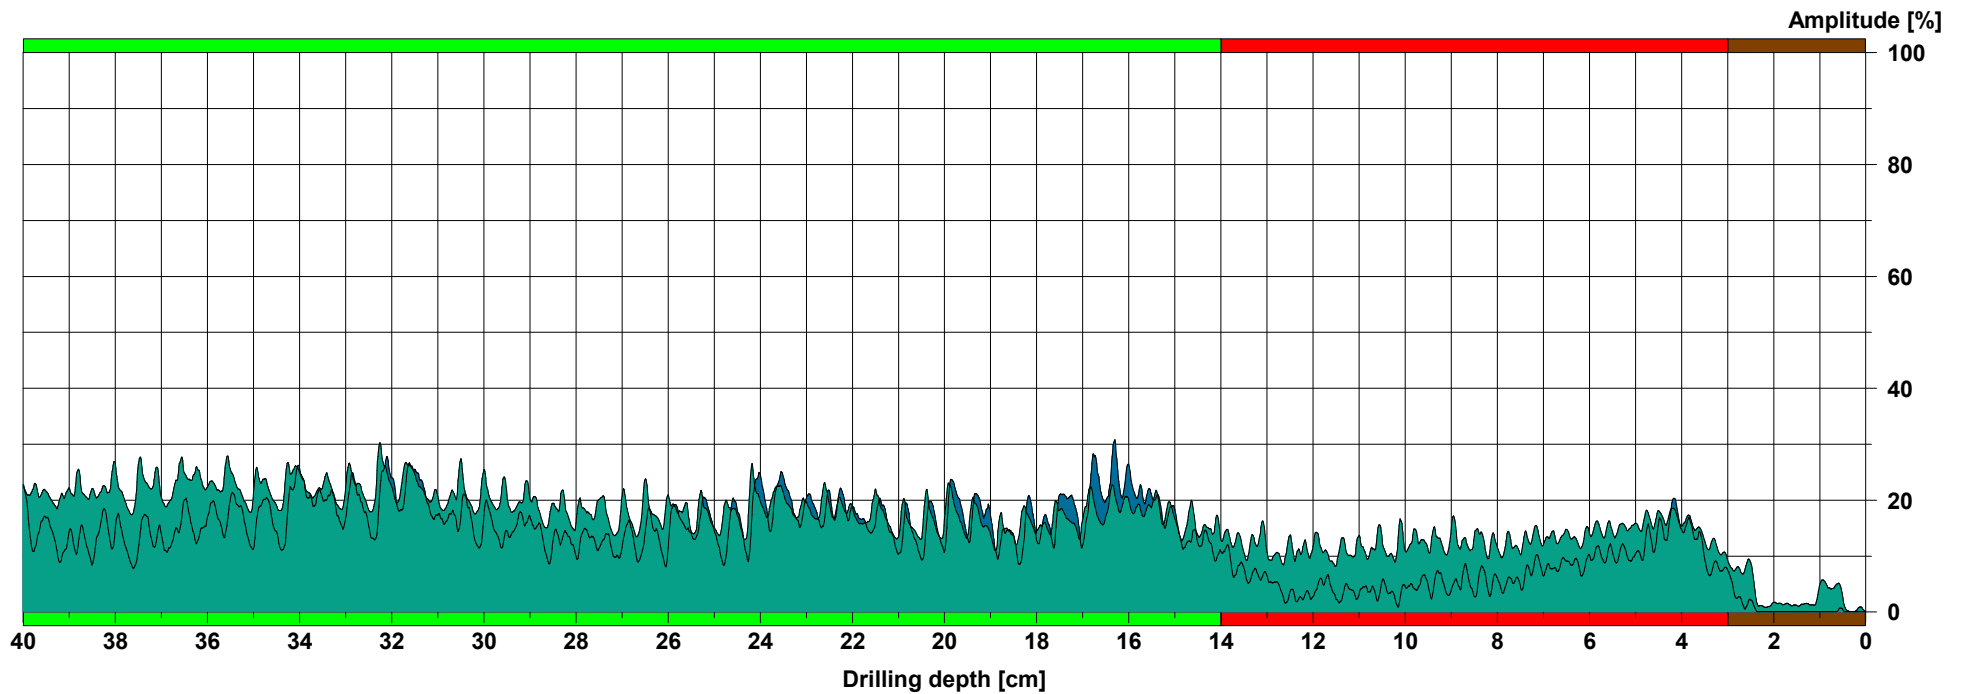
Measurement no.:	1	Speed	: 2500 r/min	Diameter:	
ID number	: MP2	Needle state:	---	Level	: 20cm
Drilling depth	: 40,14 cm	Tilt	---	Direction:	MP2
Date	: 12.11.2024	Offset	: 101 / 364	Species	: Oak
Time	: 13:28:02	Avg. curve	: off / off	Location	:
Feed	: 50 cm/min	Name	: APC

From 0,00 cm to 3,00 cm : Bark

From 3,00 cm to 14,00 cm : Decay

From 14,00 cm to 40,00 cm : Sound Wood

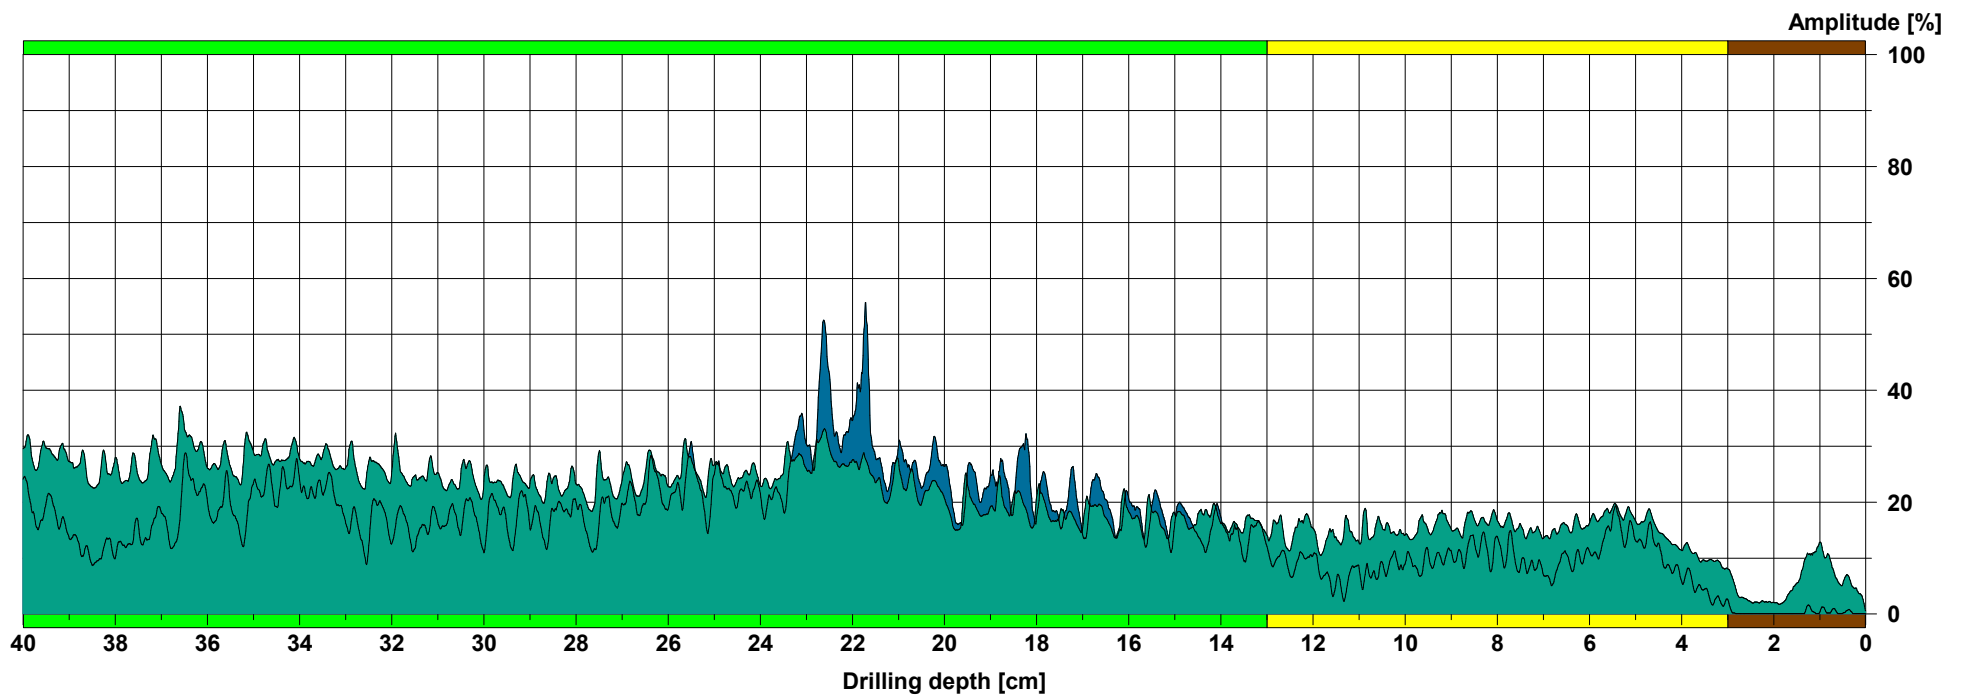
Measurement no.:	2	Speed	: 2500 r/min	Diameter:	
ID number	: MP6	Needle state:	---	Level	: 20cm
Drilling depth	: 40,15 cm	Tilt	---	Direction:	MP6
Date	: 12.11.2024	Offset	: 99 / 296	Species	: Oak
Time	: 13:30:59	Avg. curve	: off / off	Location	:
Feed	: 50 cm/min	Name	: APC

■	From 0,00 cm to 3,00 cm : Bark
■	From 3,00 cm to 13,00 cm : Low Resistance
■	From 13,00 cm to 40,00 cm : Sound Wood

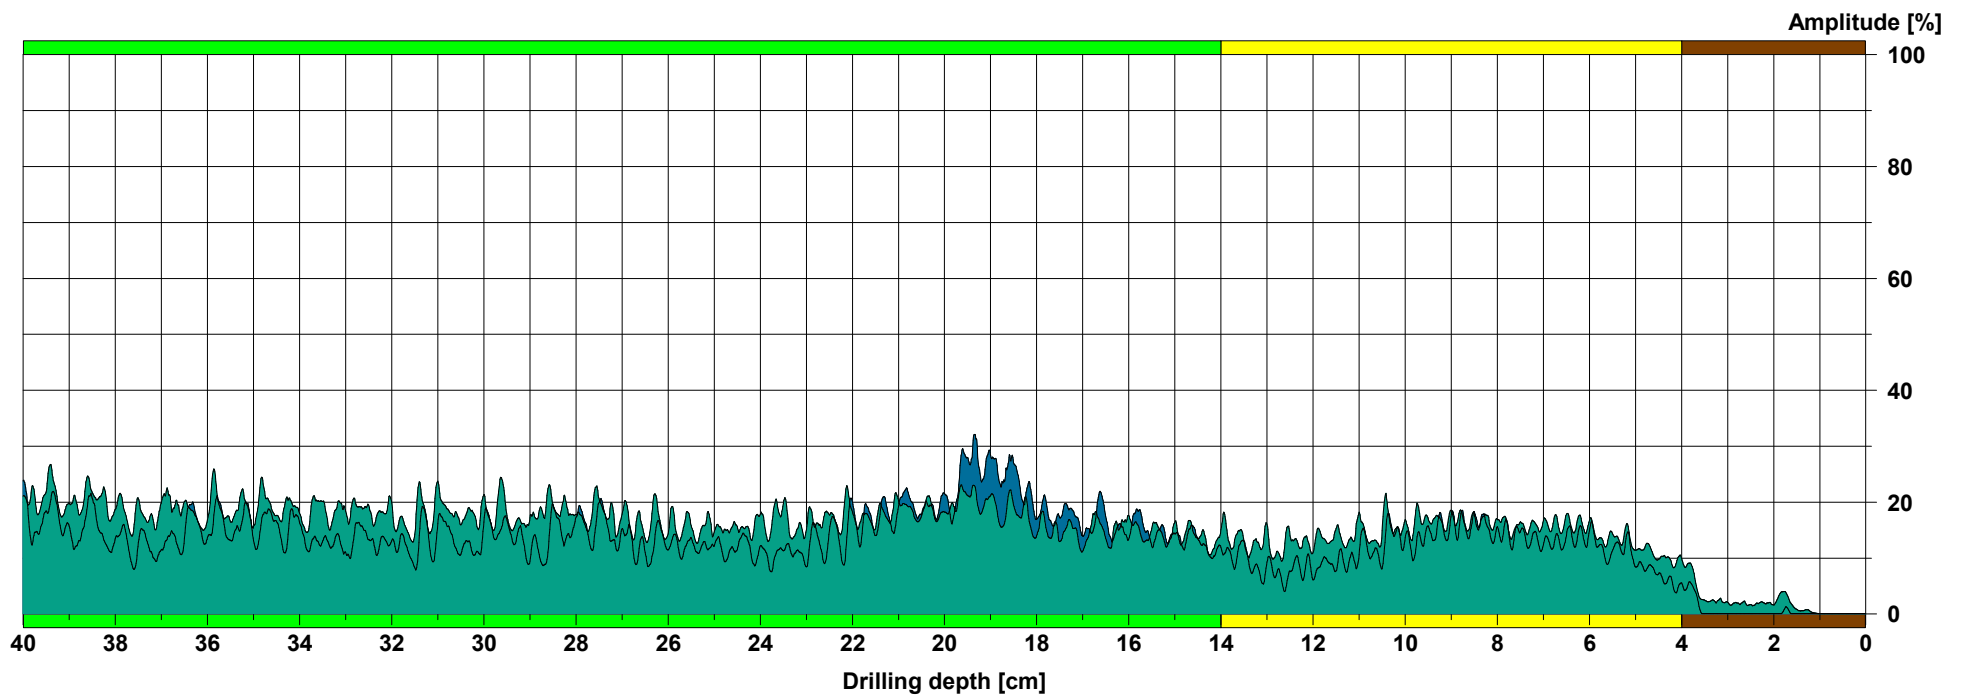
Measurement no.:	3	Speed	: 2500 r/min	Diameter:	
ID number	: MP10	Needle state:	---	Level	: 20cm
Drilling depth	: 40,15 cm	Tilt	---	Direction:	MP10
Date	: 12.11.2024	Offset	: 83 / 300	Species	: Oak
Time	: 13:32:45	Avg. curve	: off / off	Location	:
Feed	: 50 cm/min	Name	: APC

■	From 0,00 cm to 4,00 cm : Bark
■	From 4,00 cm to 14,00 cm : Low Resistance
■	From 14,00 cm to 40,00 cm : Sound Wood

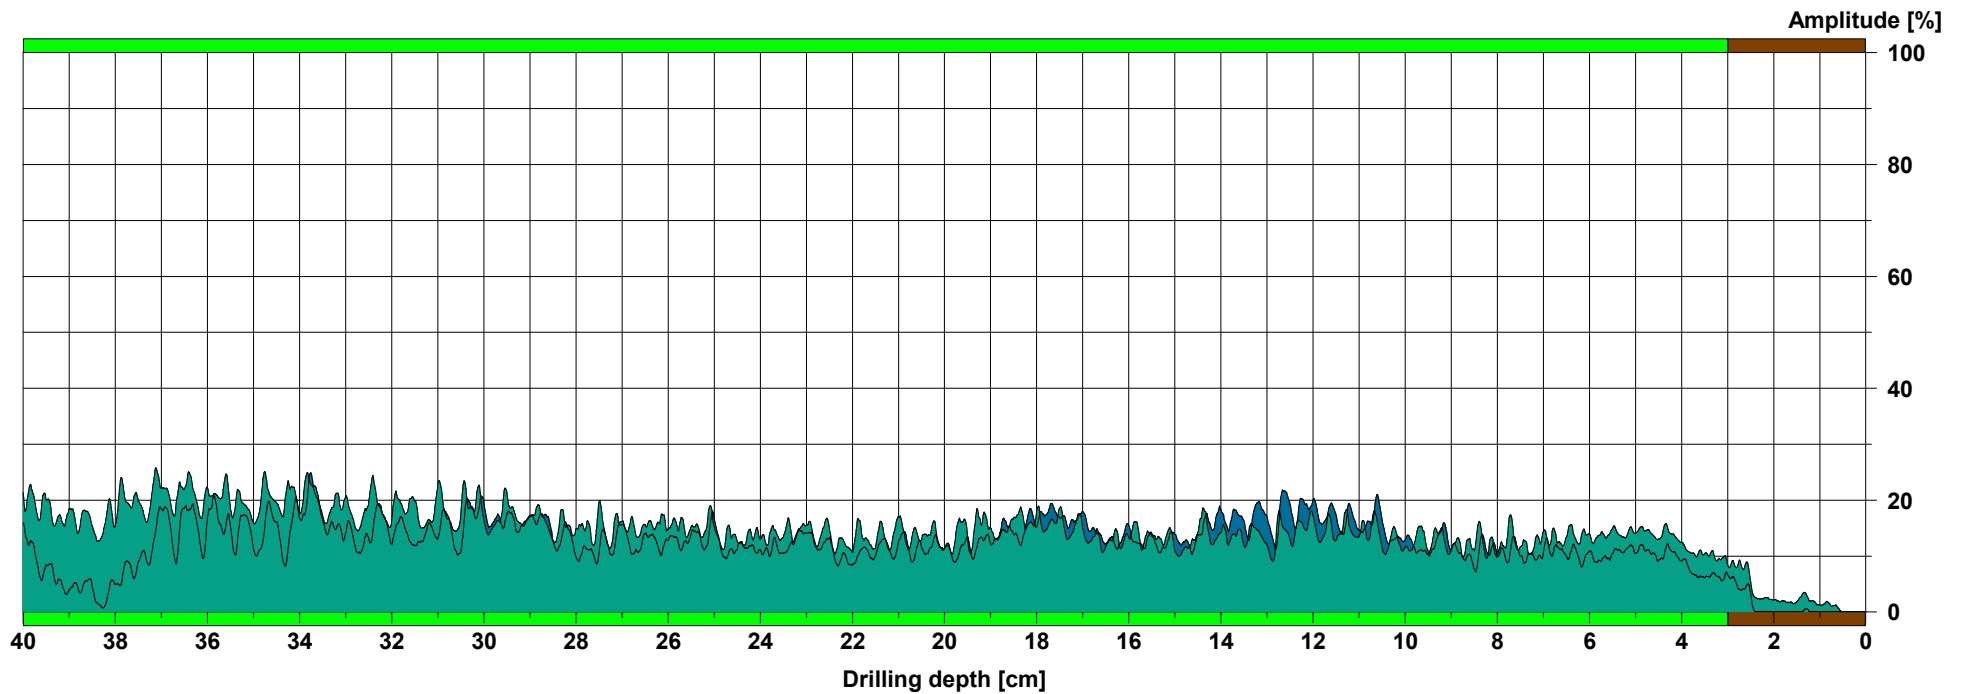
Measurement no.:	4	Speed	: 2500 r/min	Diameter:	
ID number	: MP12	Needle state:	---	Level	: 20cm
Drilling depth	: 40,15 cm	Tilt	---	Direction:	MP12
Date	: 12.11.2024	Offset	: 81 / 290	Species	: Oak
Time	: 13:36:14	Avg. curve	: off / off	Location	:
Feed	: 50 cm/min	Name	: APC

From 0,00 cm to 3,00 cm : Bark

From 3,00 cm to 40,00 cm : Sound Wood
